Tower Alert – 10 Nov 2003

Tower Leg Damage Due to Corrosion

**Attention Tower Professionals:
Be aware of possibility of corrosion inside tower legs.**

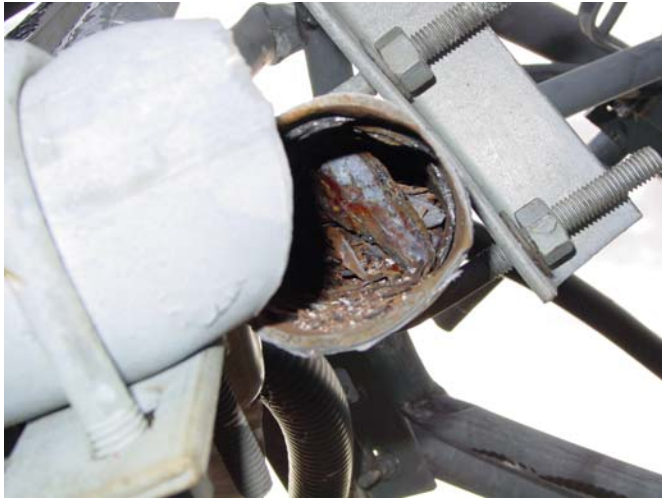
Corrosion inside tower leg – Nov 2003

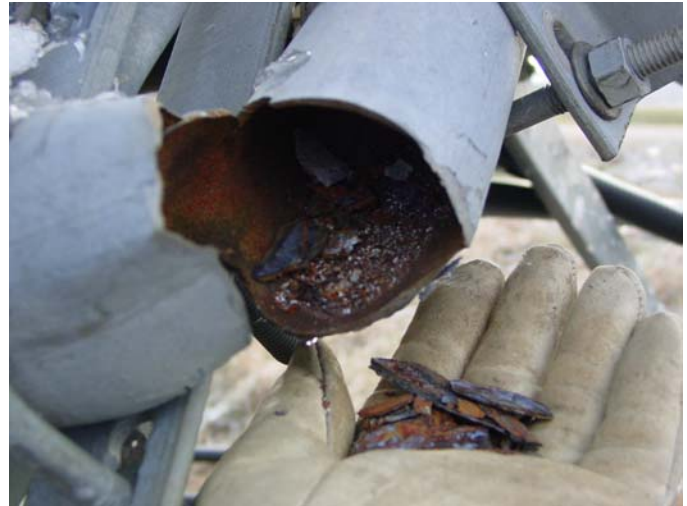
Note leg wall thickness – should be schedule 40. Nov 2003

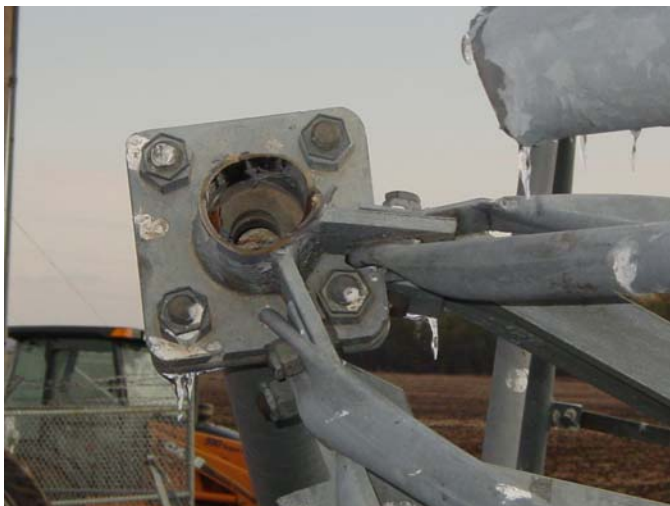
Broken leg from same tower – Normal leg thickness – Nov 2003
